**HOME
INSPECTION
REPORT**

Inspection Date:
07/22/2025

Prepared By:
Komatina's Home Inspections

22 Poinsettia Dr
Deland Fl 32724

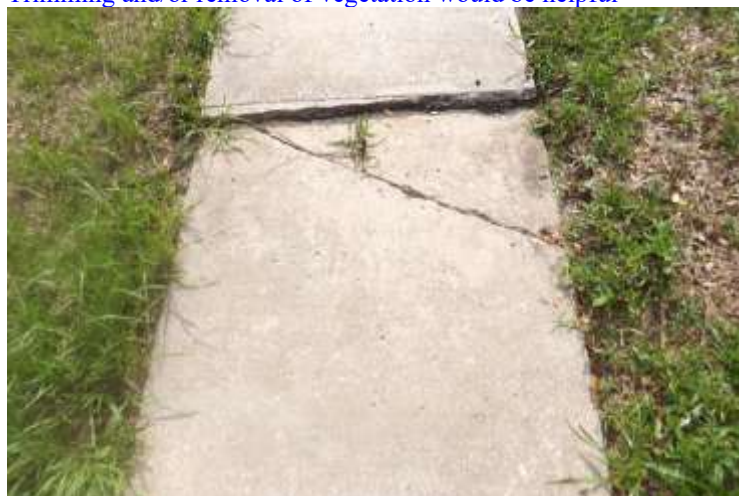
Front walkway trip hazard

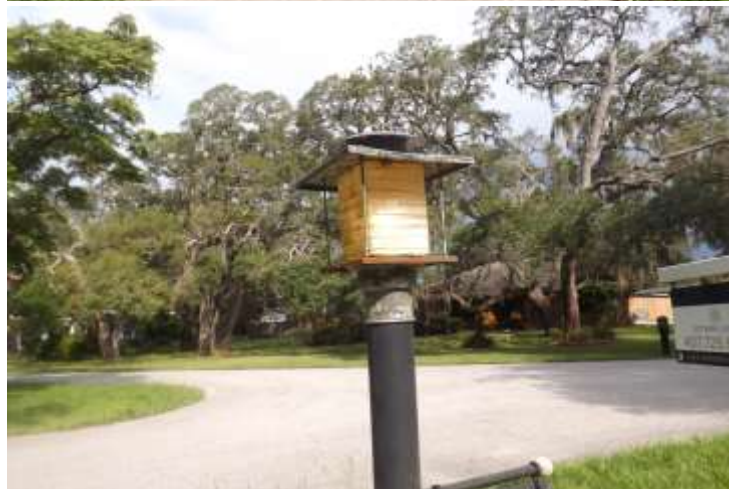
Front light pole outlet open ground GFCI protected

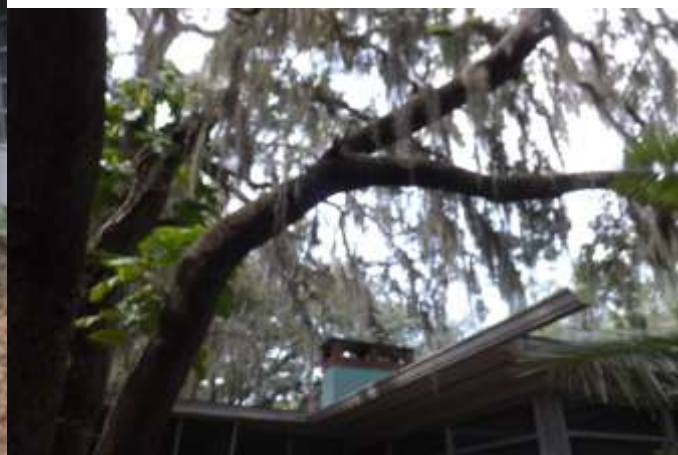
Trees appears to be oak should be at least 25 feet or more from home/Branches Hanging Over Home

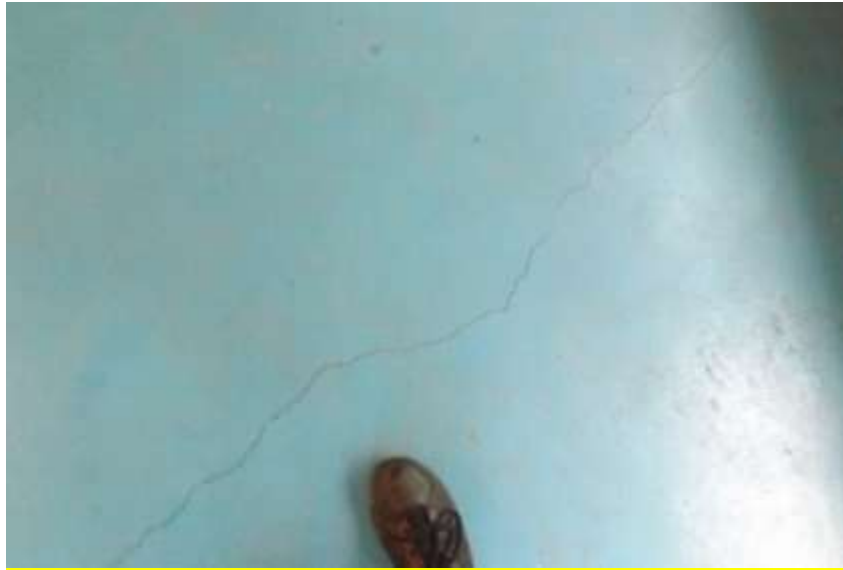
Settlement cracks appears to cause by

trees roots-Evaluation needed

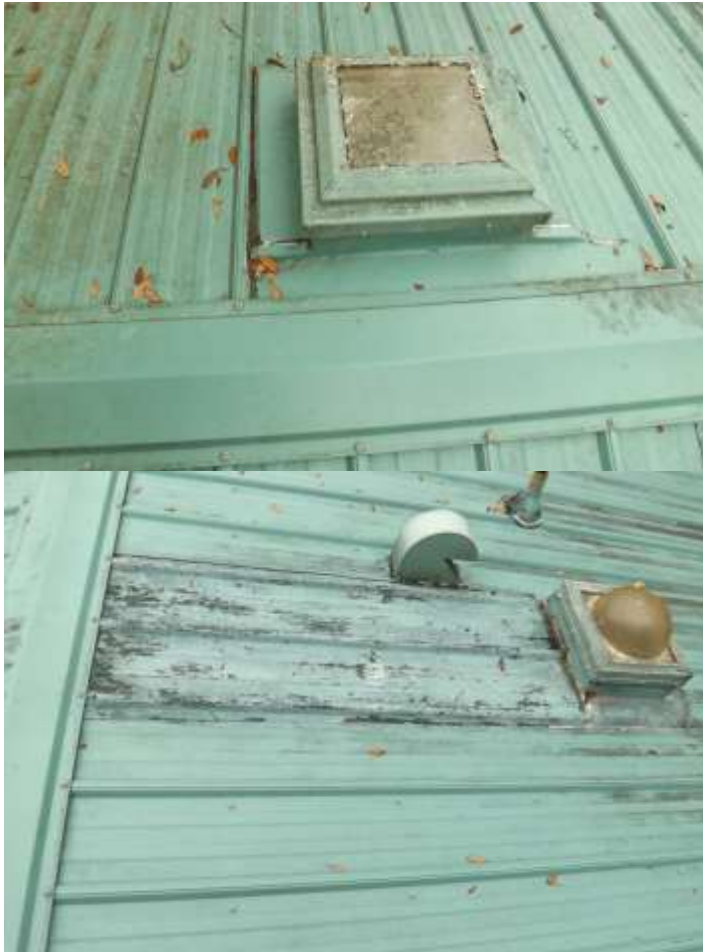
Skylights appears to be old or just very dirty from trees

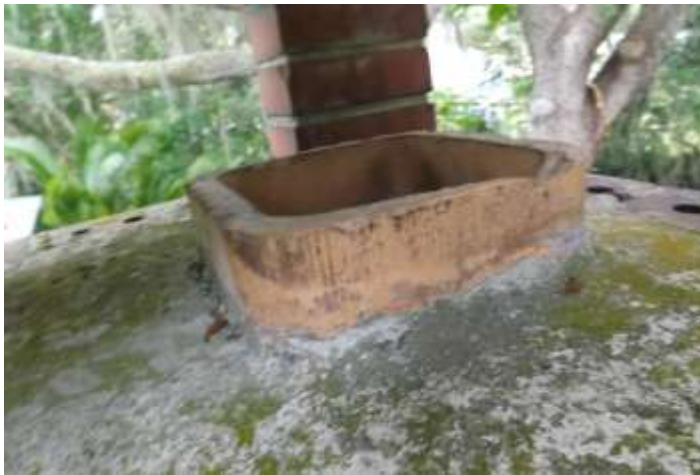
Chimney crown cleaning need & Seal cracks

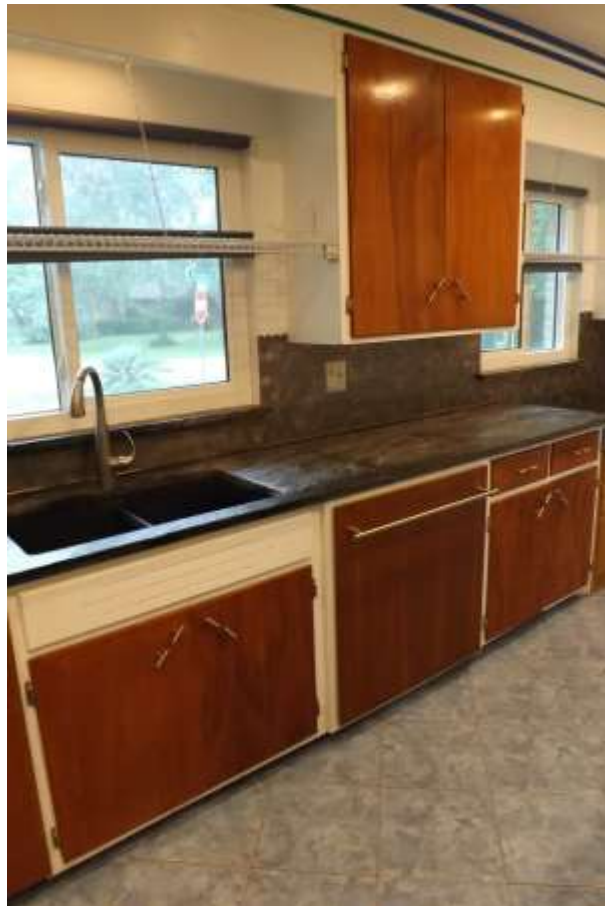
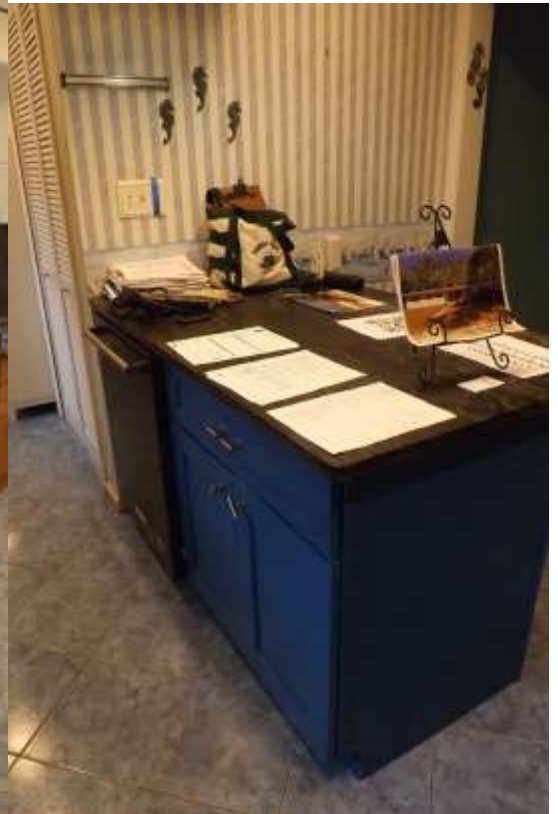
Dishwasher not working light come on

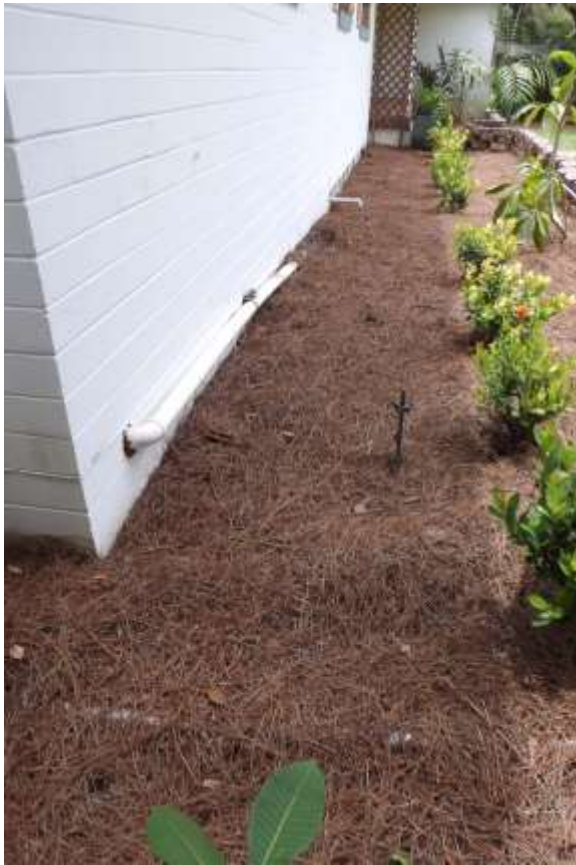
Washer drain going into ground not sure if hook

up to septic, License plumber evaluation needed.

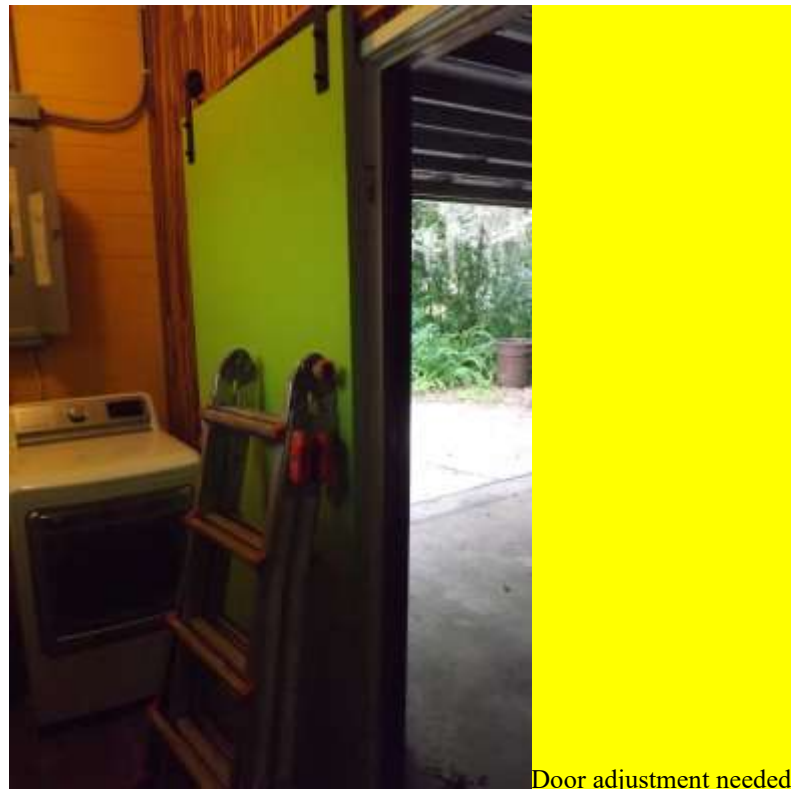
Door adjustment needed.

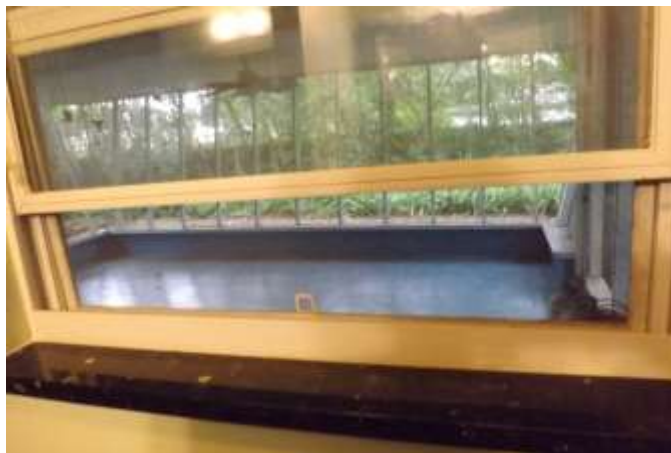
glass doesn't appear to be tamper replacement due to very dangerous

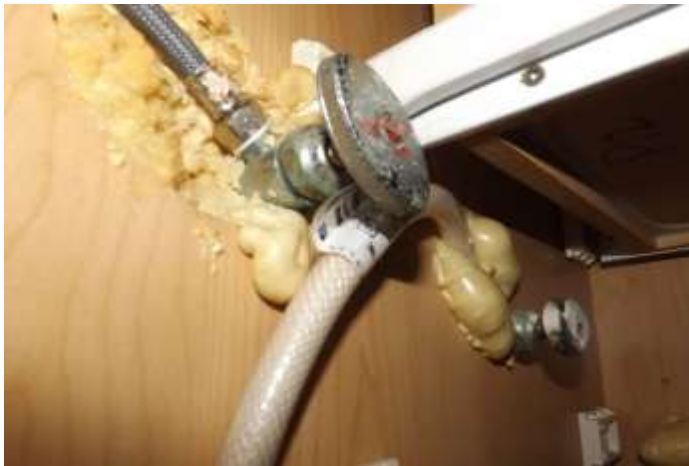
Shutoff handle appears to be crack replacement needed-Water pipes not visible

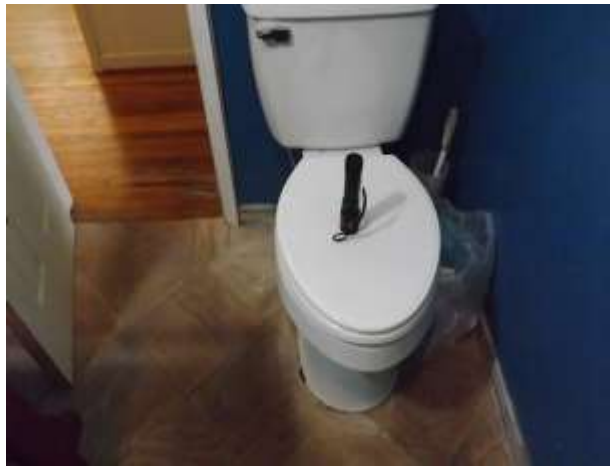
Toilet bowl loose repair needed

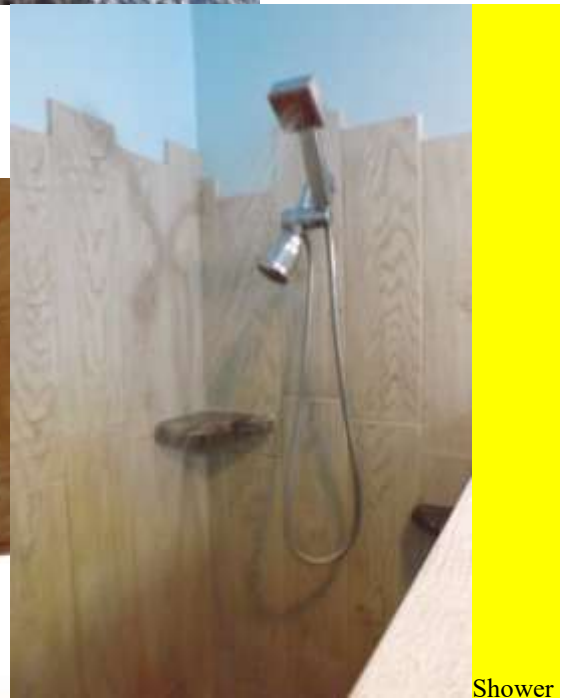
was remodel don't know if pan liner was use or concrete board for walls

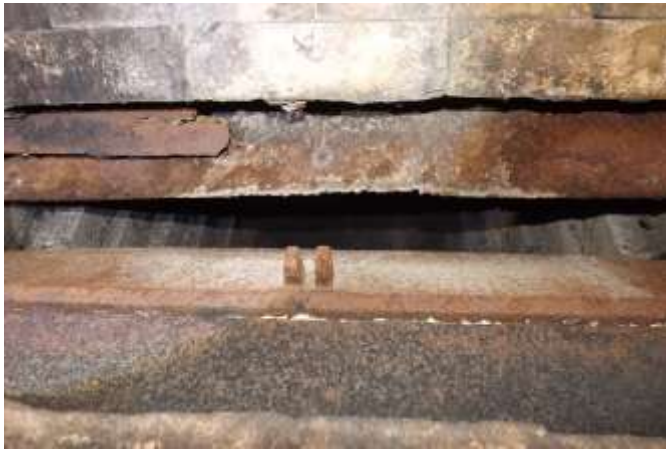
Fireplace Hearth extension requires 16 inches

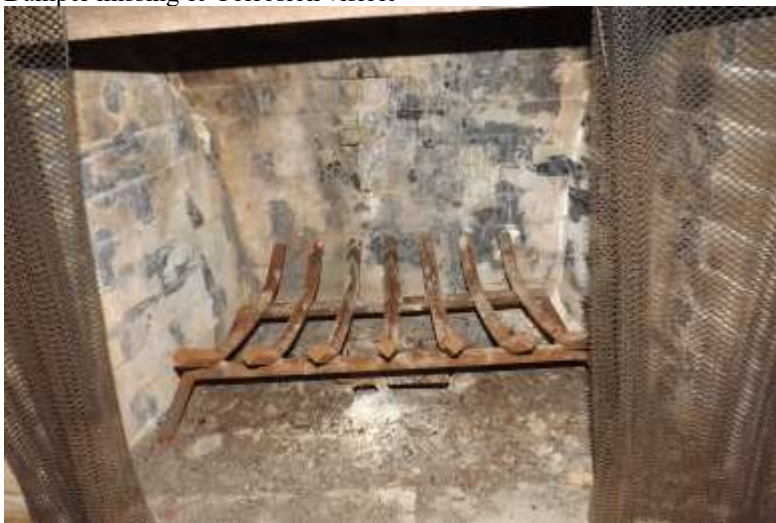
Damper missing & Corrosion visible

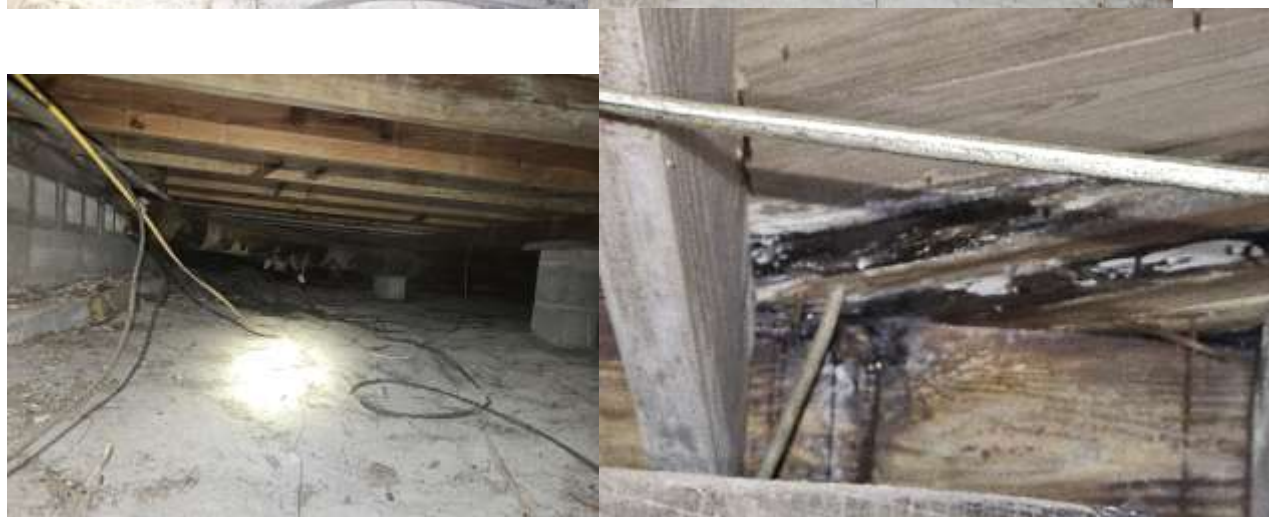
Mois

ture wood damaged this is under Air Handler

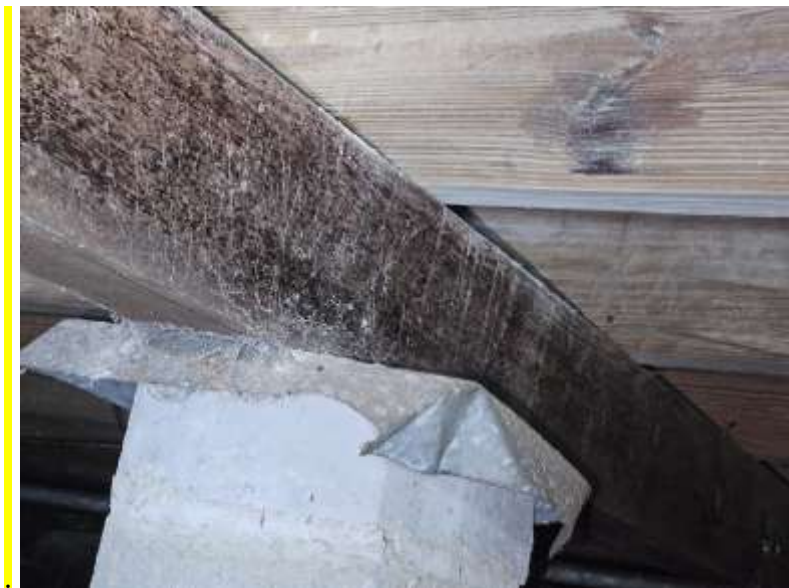
Duct system metal insulation deteriorating

replacement needed

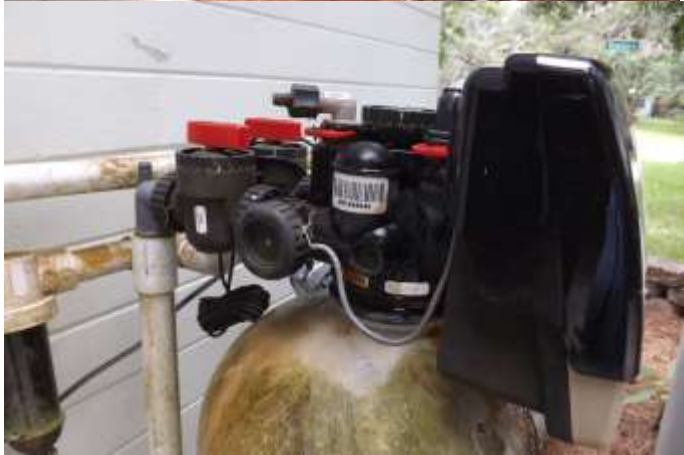
Water softener leak, Repair needed

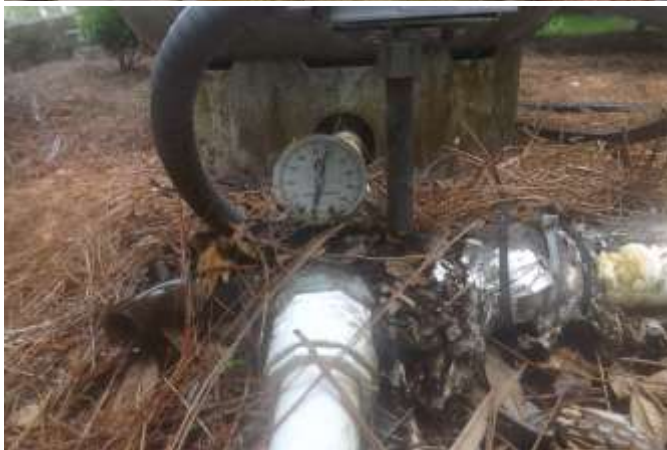
Gauge glass broken gauge appears to be working

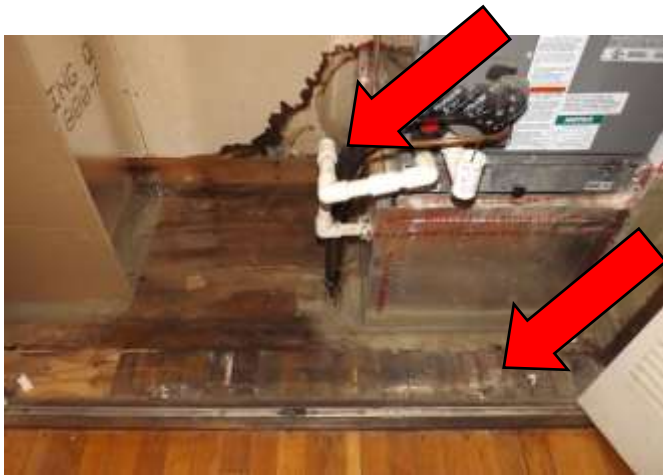
Air Handler leaking water damaged wall & floor

repair needed.

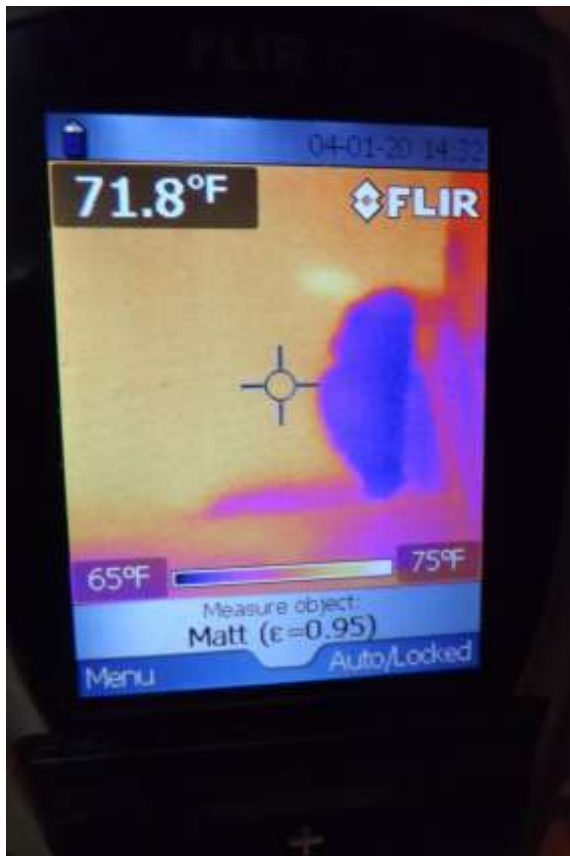
Infrared camera moisture damaged wall & Floor Repair

Moisture meter 97%

needed.

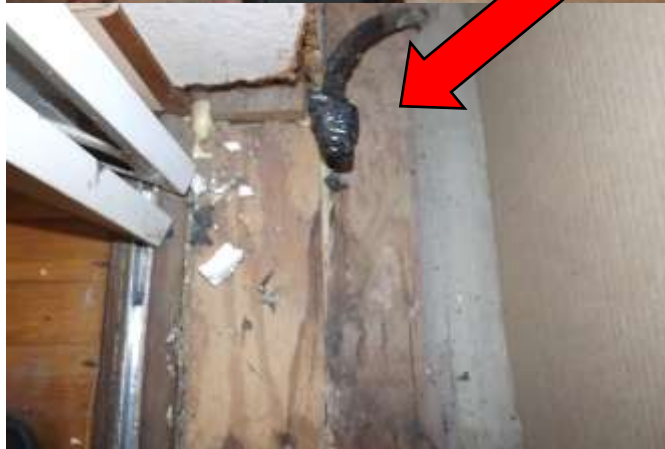
Closet expose wiring need to be removed or

installed in junction box with cover.
