**HOME
INSPECTION
REPORT**

Inspection Date:
07/22/2025

Prepared By:
Komatina's Home Inspections

22 Poinsettia Dr
Deland Fl 32724

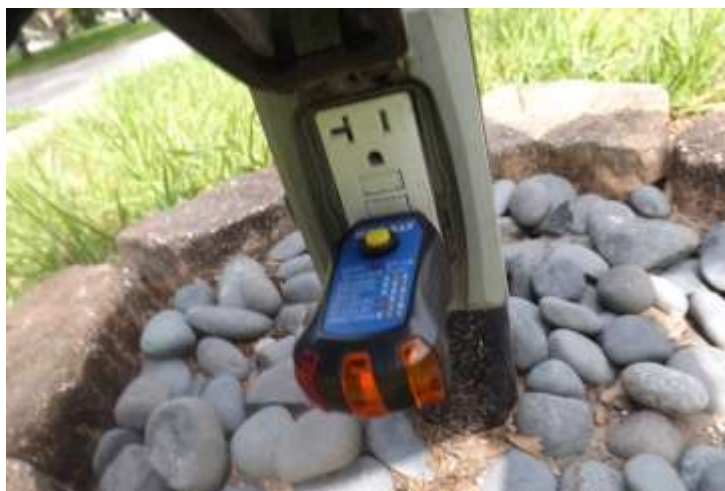
Front light pole outlet open ground GFCI protected

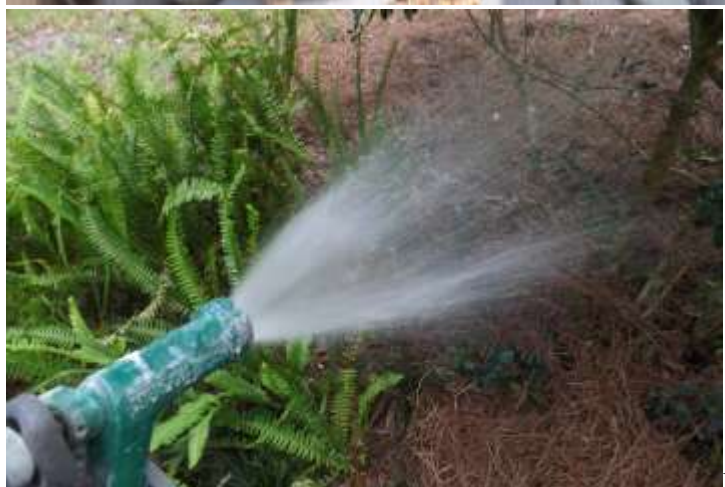
Hose Bibs in good working condition

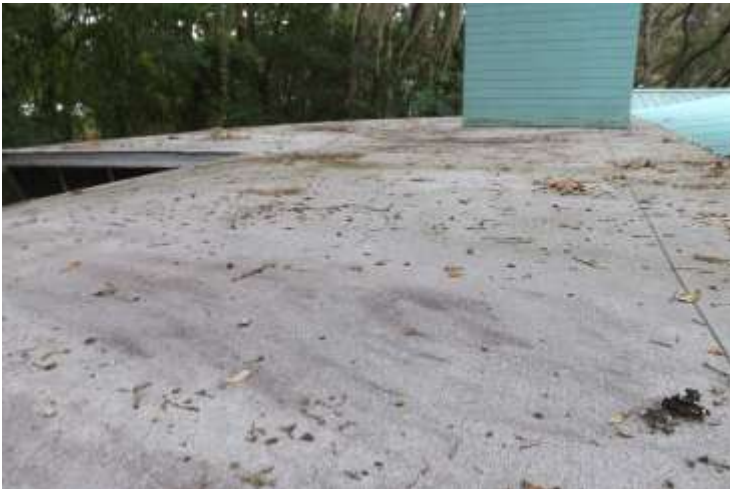
Flat roof Roof Adhered Modified Membrane

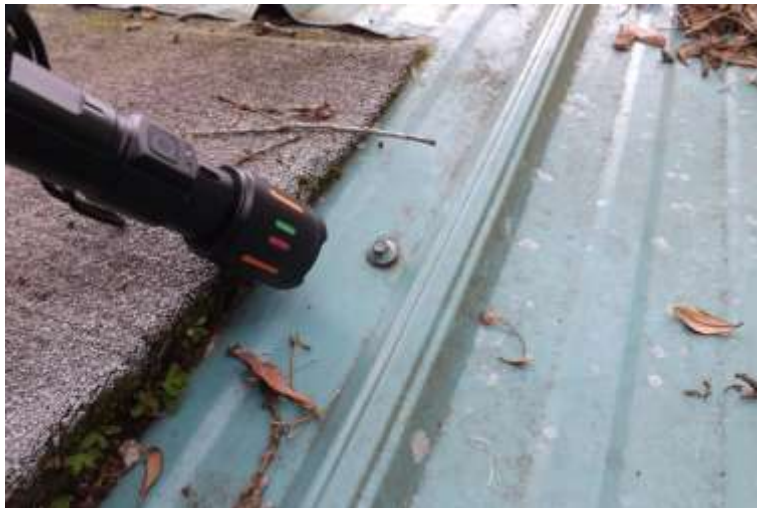
Roof screw installed in angle should be flat

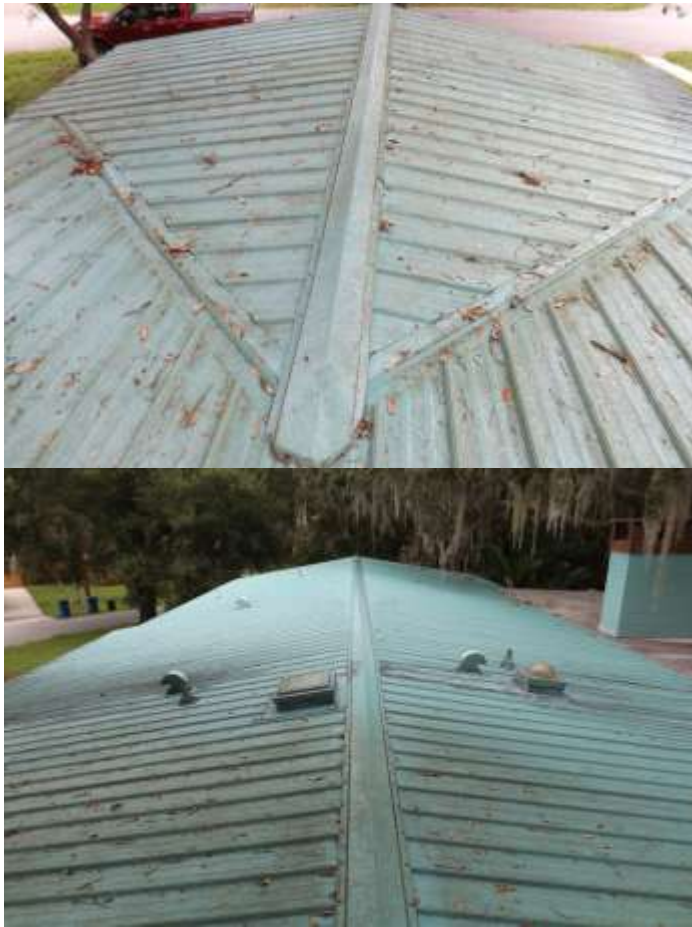
Skylights appears to be old or just very dirty from trees

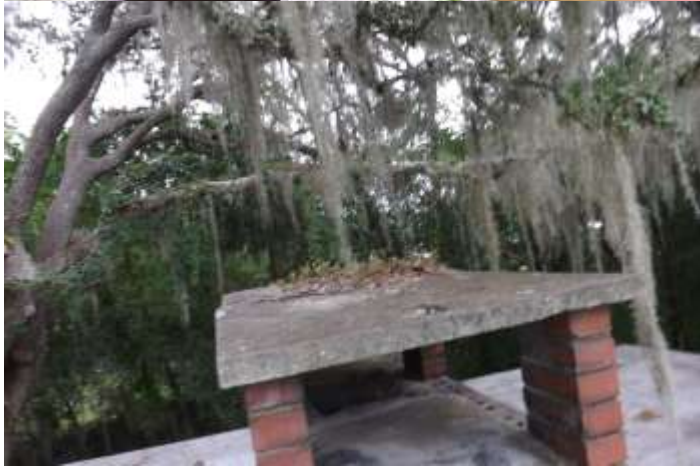
Chimney crown cleaning need & Seal cracks

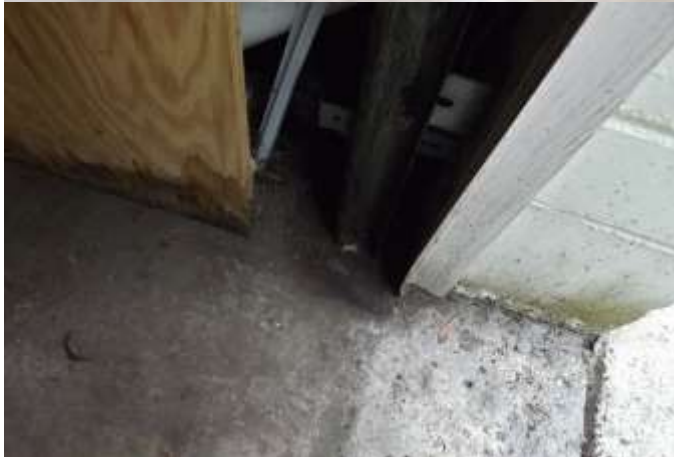
Garage safety beams in good working condition

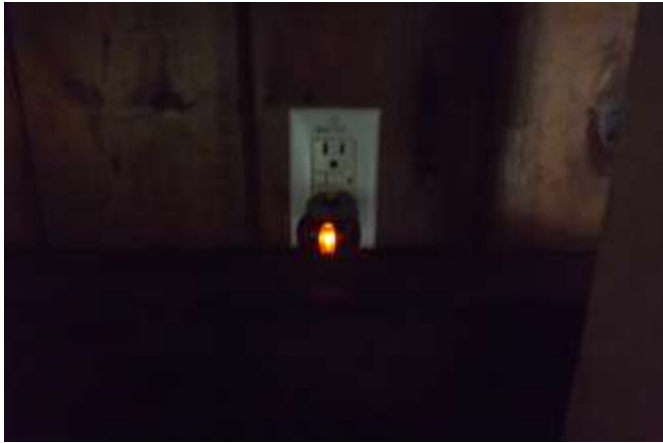
Open Ground /GFCI Protected

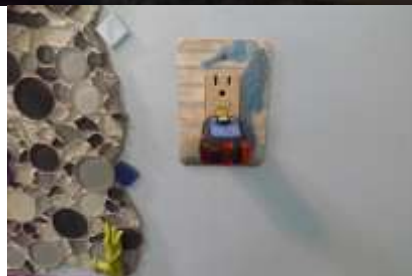
GFCI in good working condition

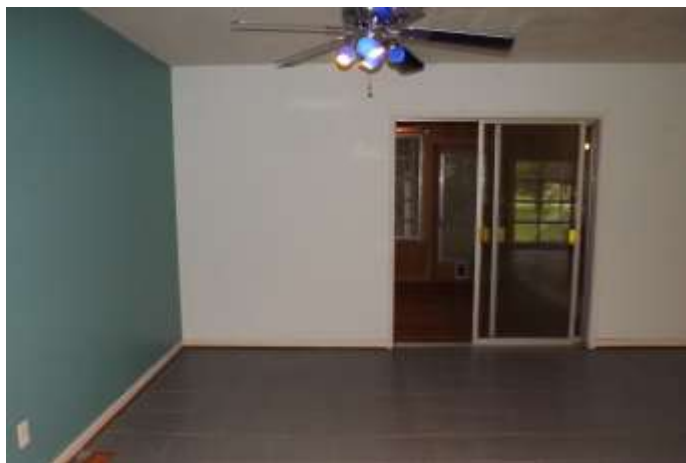
Sliding door in good working condition

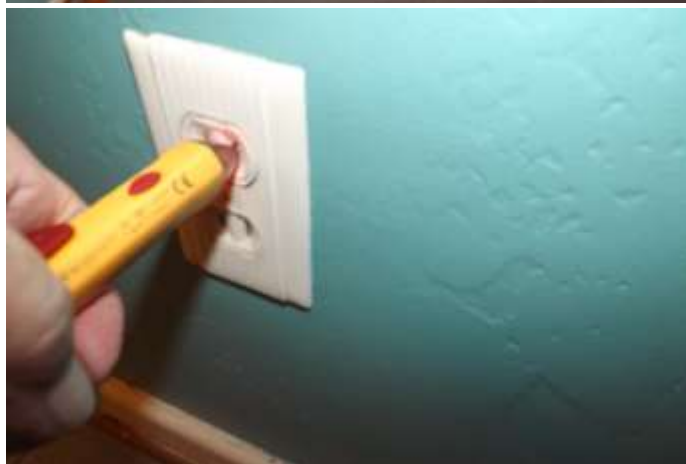
Outlet Open Ground GFCI Protected.

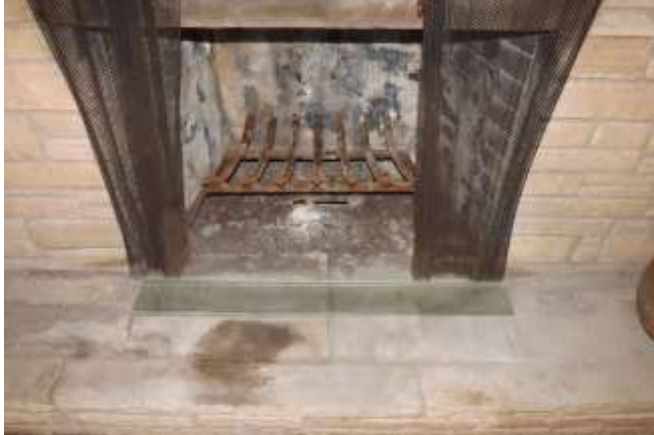
Fireplace Hearth extension requires 16 inches

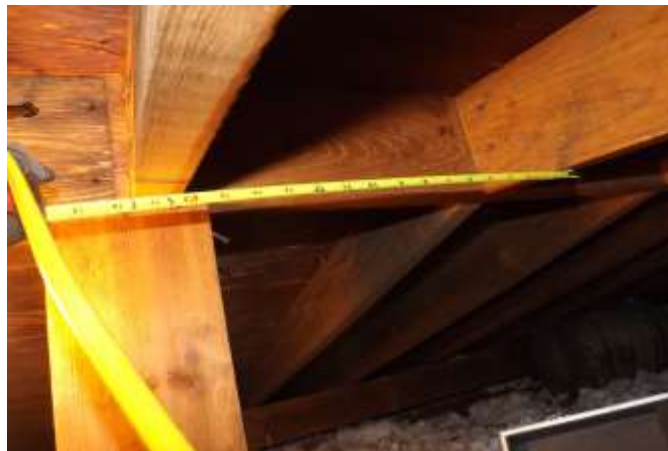
Rafters 16 inches spacing

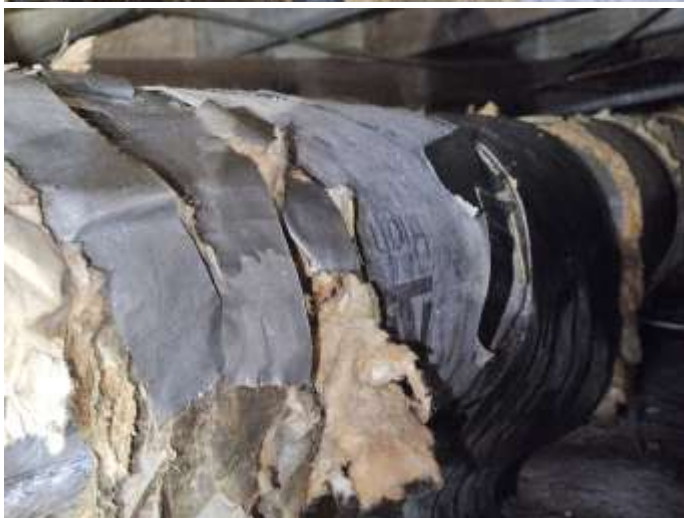
Duct system metal insulation deteriorating

replacement needed

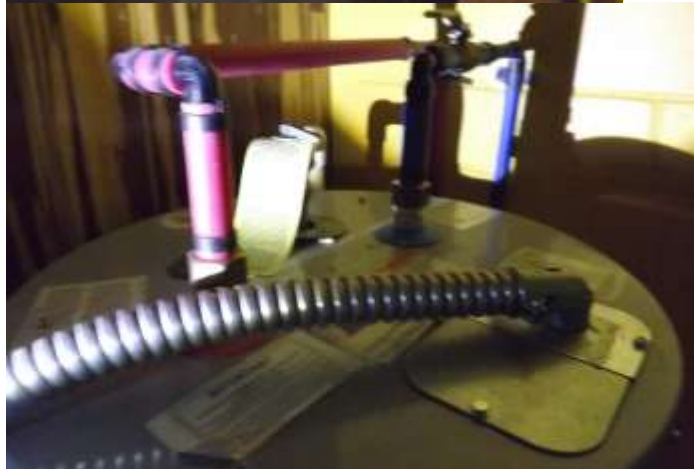
Water Pipe Copper & PEX

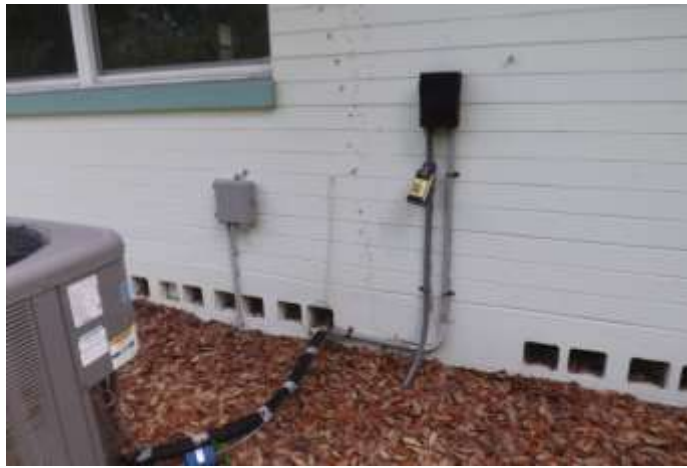
Can't find AC drain line
