**HOME
INSPECTION
REPORT**

Inspection Date:
07/22/2025

Prepared By:
Komatina's Home Inspections

22 Poinsettia Dr
Deland Fl 32724

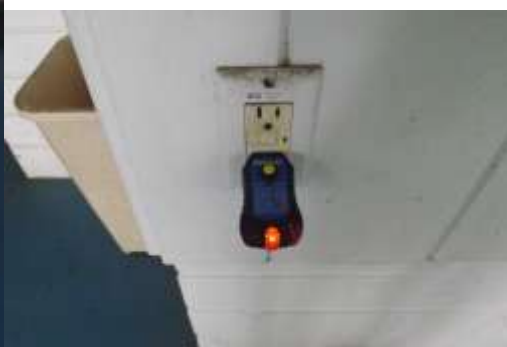
Outlet open

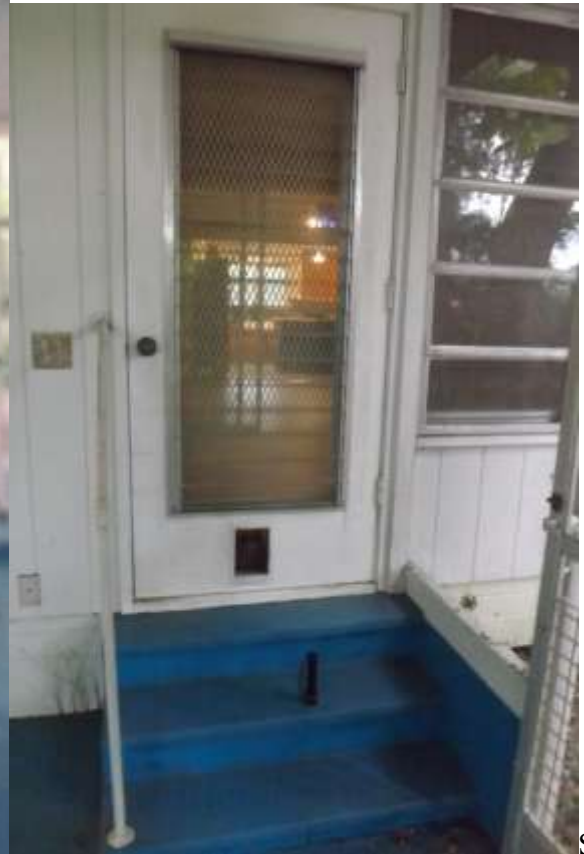
Step

are high use caution

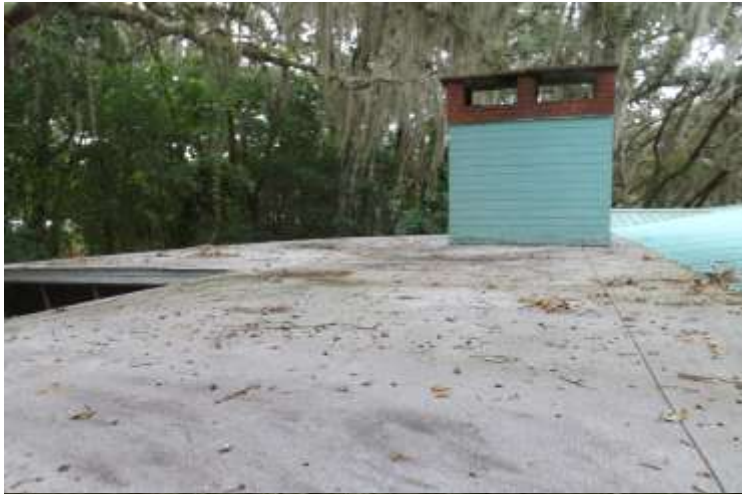
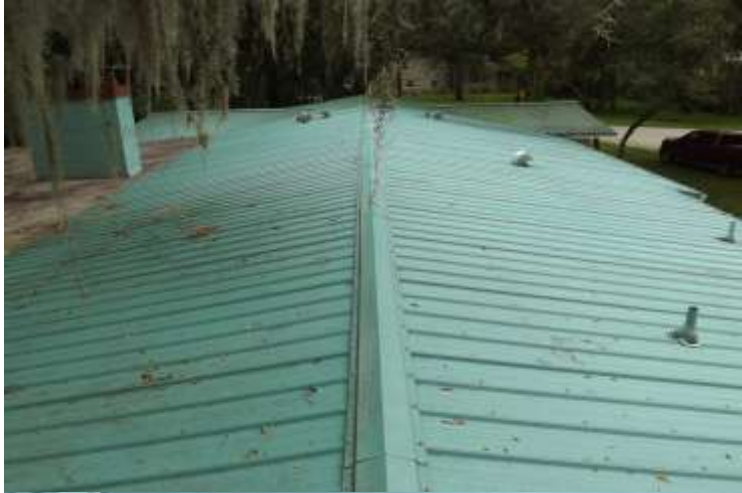
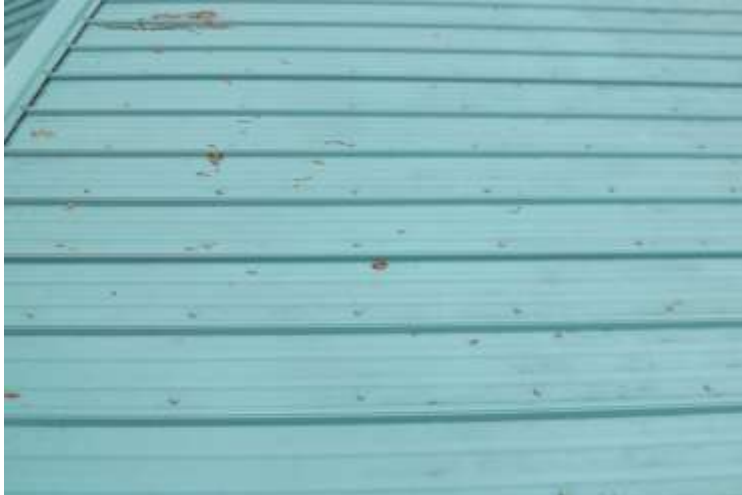
Roof screw life expectancy 15 to 25 years plan budget

replacing

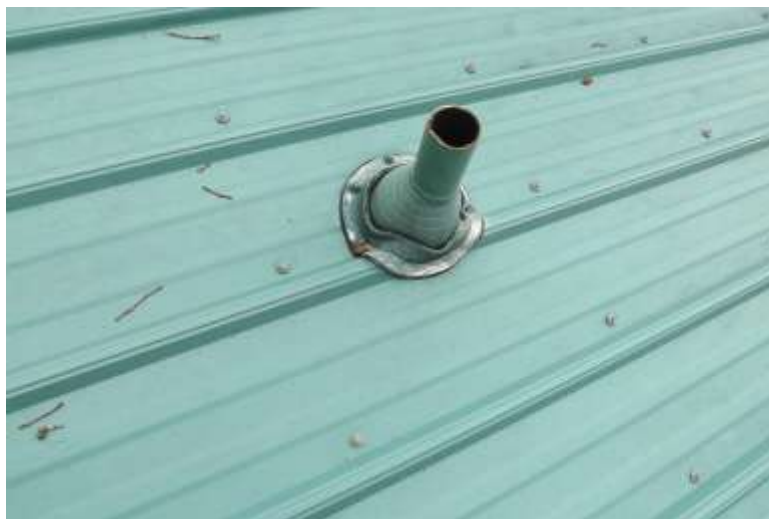
Waste vent booth normally have continuous screw

due to position

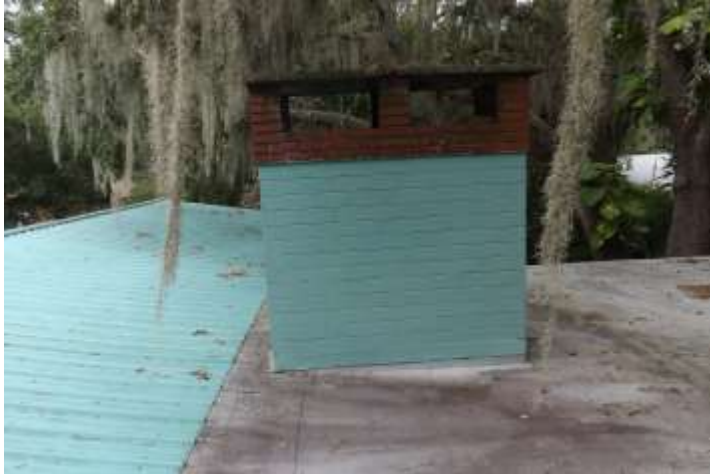
Tree branches hanging over home

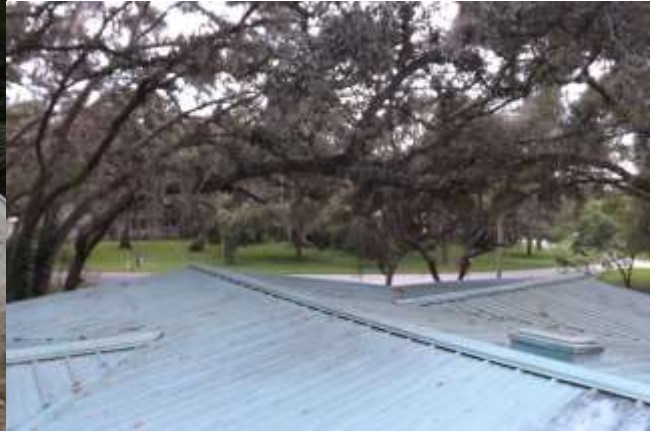
Tree branches hanging over home

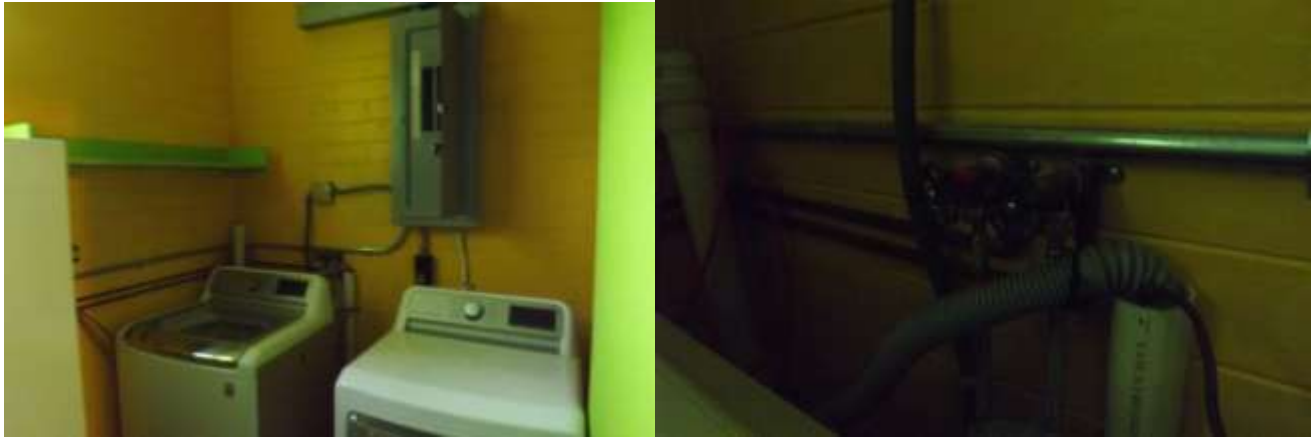
Washer drain going into ground not sure if hook

up to septic, License plumber evaluation needed.

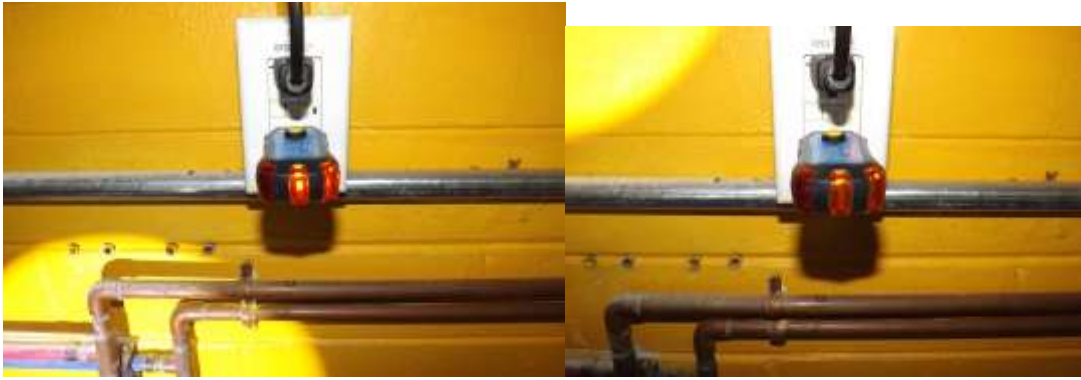
Tested in Good Working Condition.

Out GFCI Protected

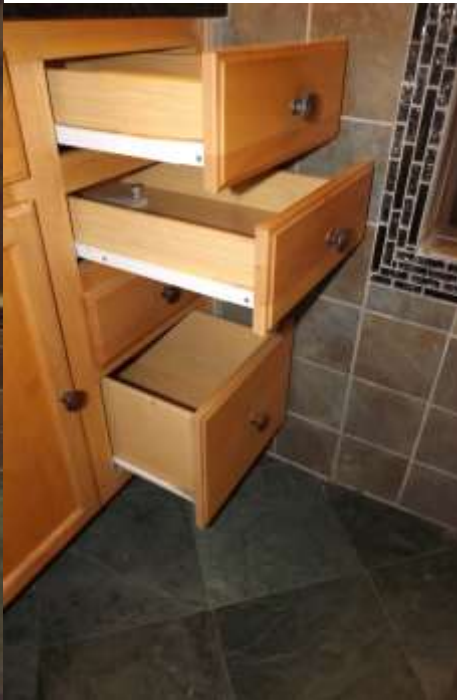
3rd draw stuck

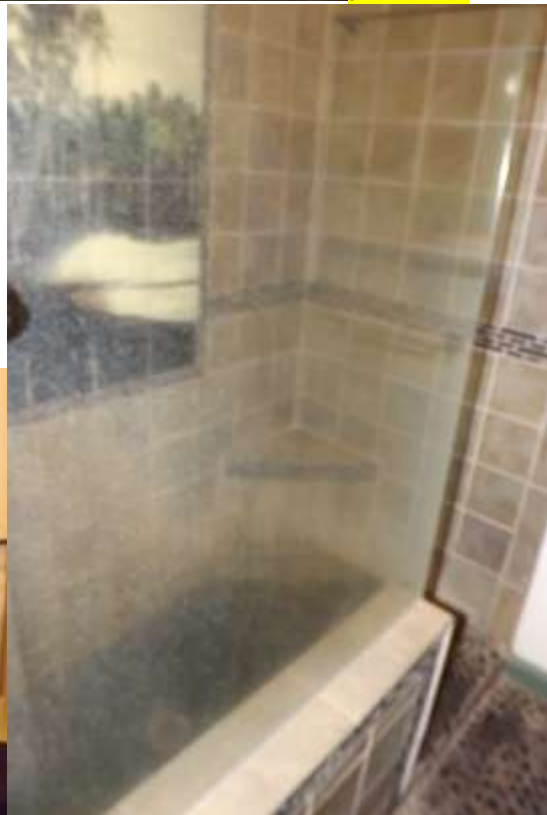
glass doesn't appear to be tamper replacement due to very dangerous

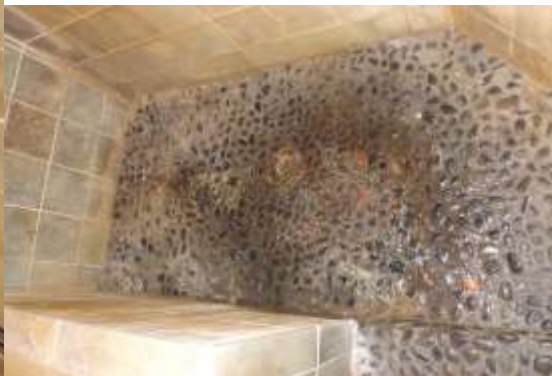
liner was use.

Shower remodel don't know if pan

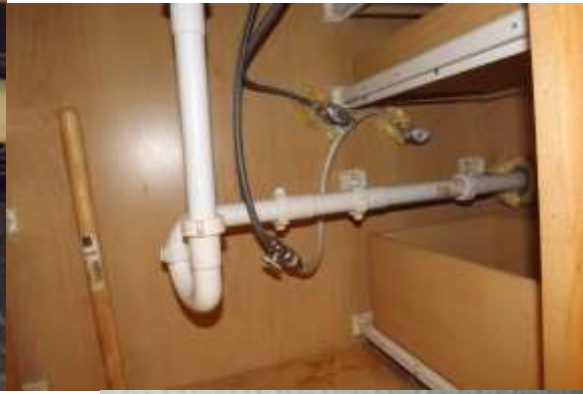
Shutoff handle appears to be crack replacement needed-Water pipes not visible

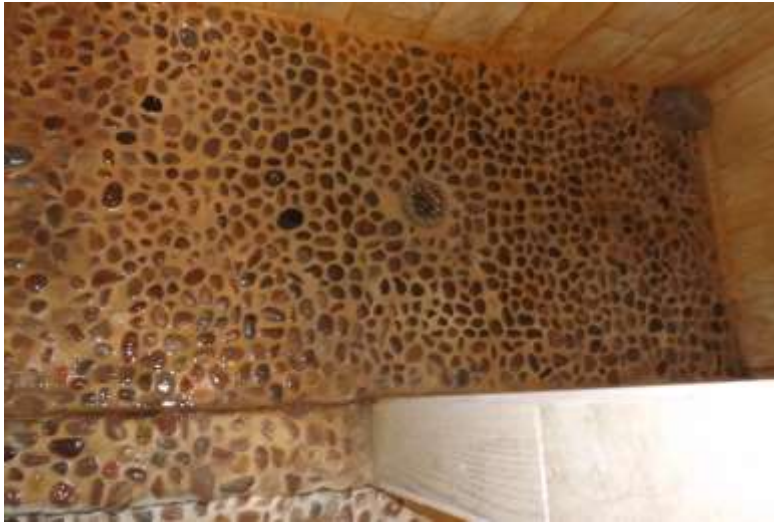
Shower

was remodel don't know if pan liner was use or concrete board for walls

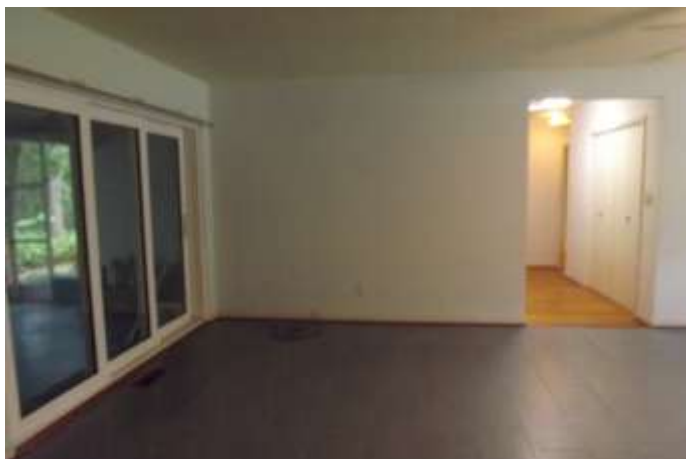
Outlets open ground in good working condition & fan in good working condition

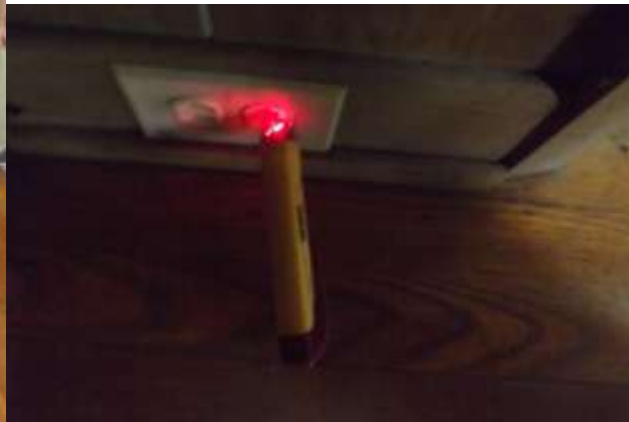
Outlets open

ground in good working condition/OLD FASHION CRACKOUT WINDOWS

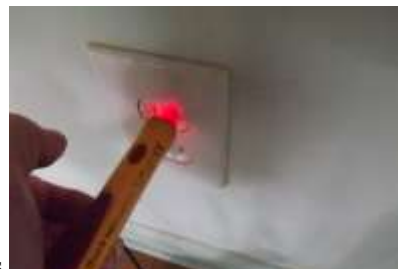
outlets open ground in good

working condition

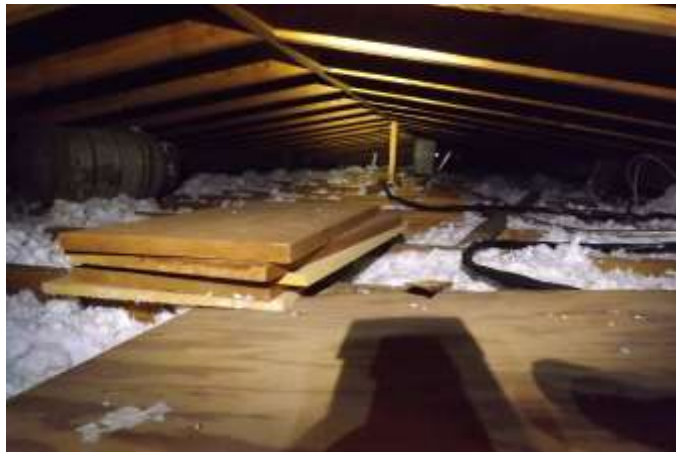
Recoomend additional insulation

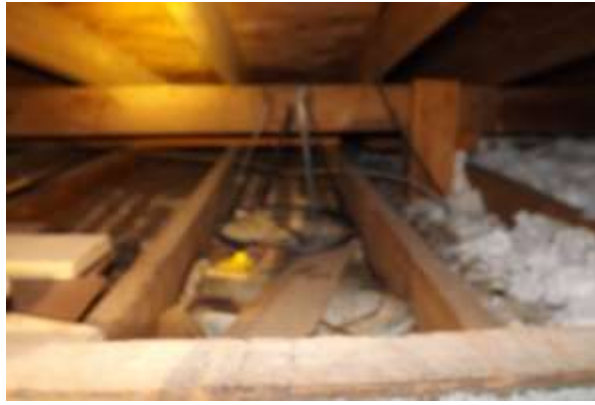
Rat Trap/No Rottens

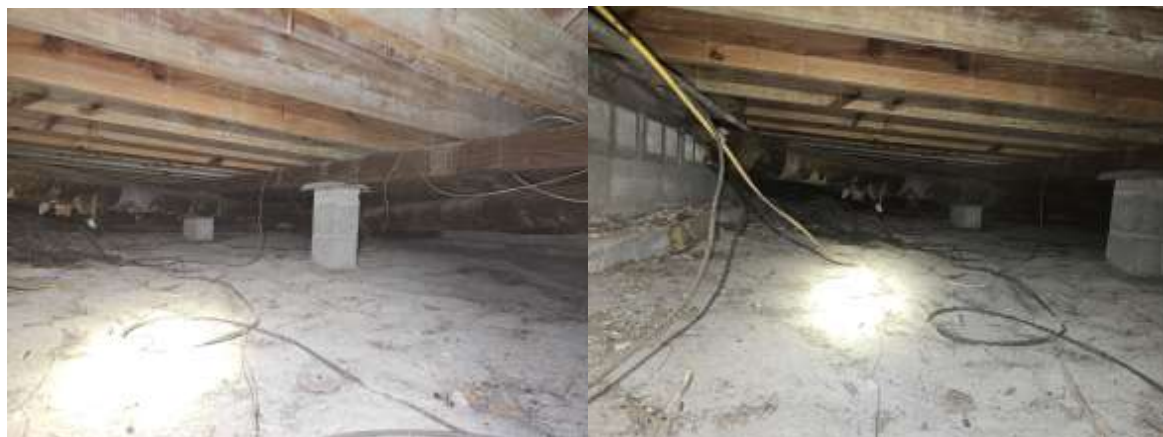
Mois

ture wood damaged this is under Air Handler

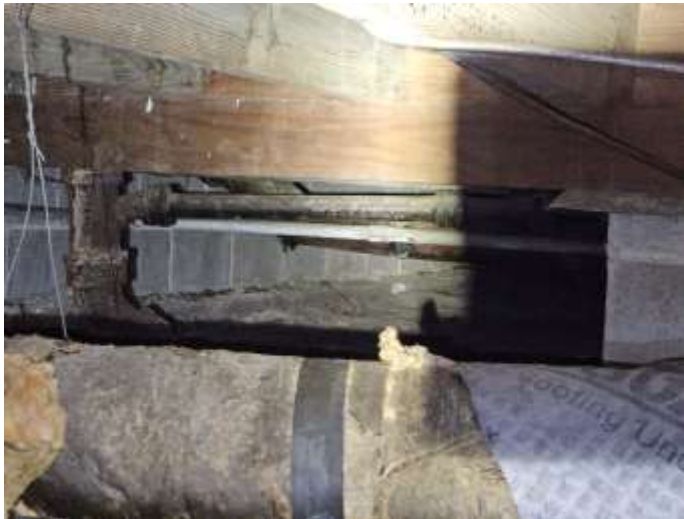
Drain Cast Iron

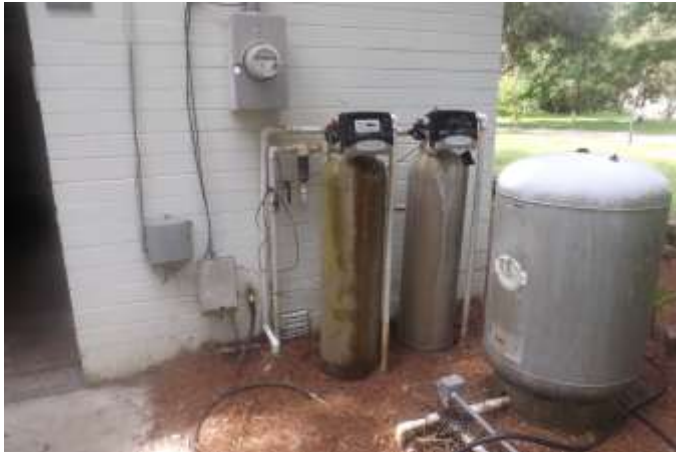
Water softener leak, Repair needed
